REFERENCE

Commercial Building, Ashgabad / Turkmenistan

Brief Description

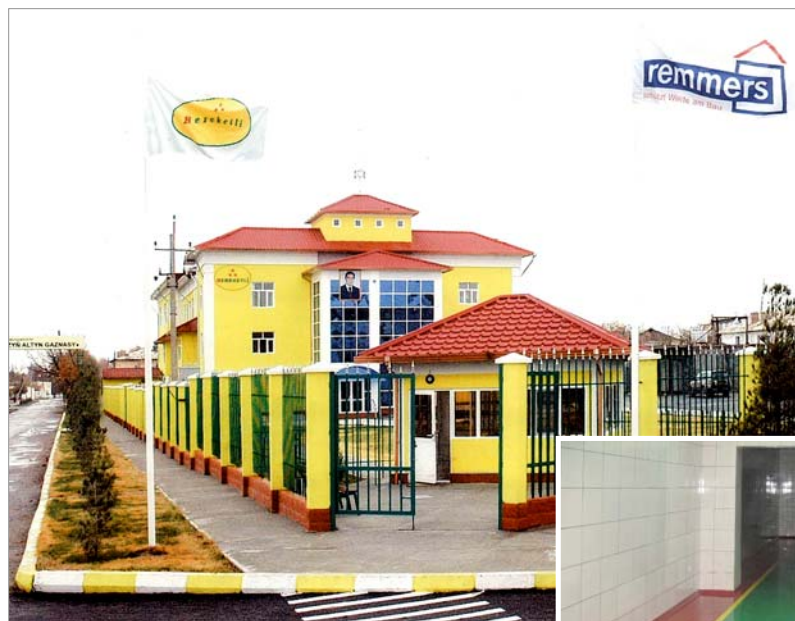
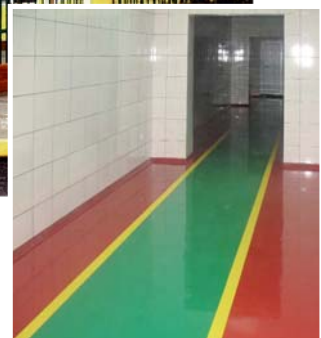
Restoration of a commercial building on the Grand Silk Road, one of the oldest trade routes in the world. Different production areas such as a butcher's and a tea processing operation are situated in the building.

Restoration of the facade as well as restoration of the concrete pillars. The floor, which is subjected to heavy loads, was given a completely new coating.

Crack restoration: Bonding Mortar S
Primer coating: Silicone Resin Filling Paint LA
Coating: Silicone Resin Paint SF

Filling mortar: Betofix RM
Coating: Silicone Resin Paint SF
Metal coating: Aidol Color Varnish

Scratch coat: Epoxy ST 100 / Quartz
Sealant: Epoxy OS Color
Slip resistance: Epoxy OS Color Anti-Slip with Quartz 02/07
Coating: Epoxy OS Color and Epoxy HD Color TX
